February 16, 2018

Job No. 5208.02

Subject: Geotechnical Investigation  
Proposed Water Tank Replacement  
212 Meadowcroft Way  
Santa Rosa, California

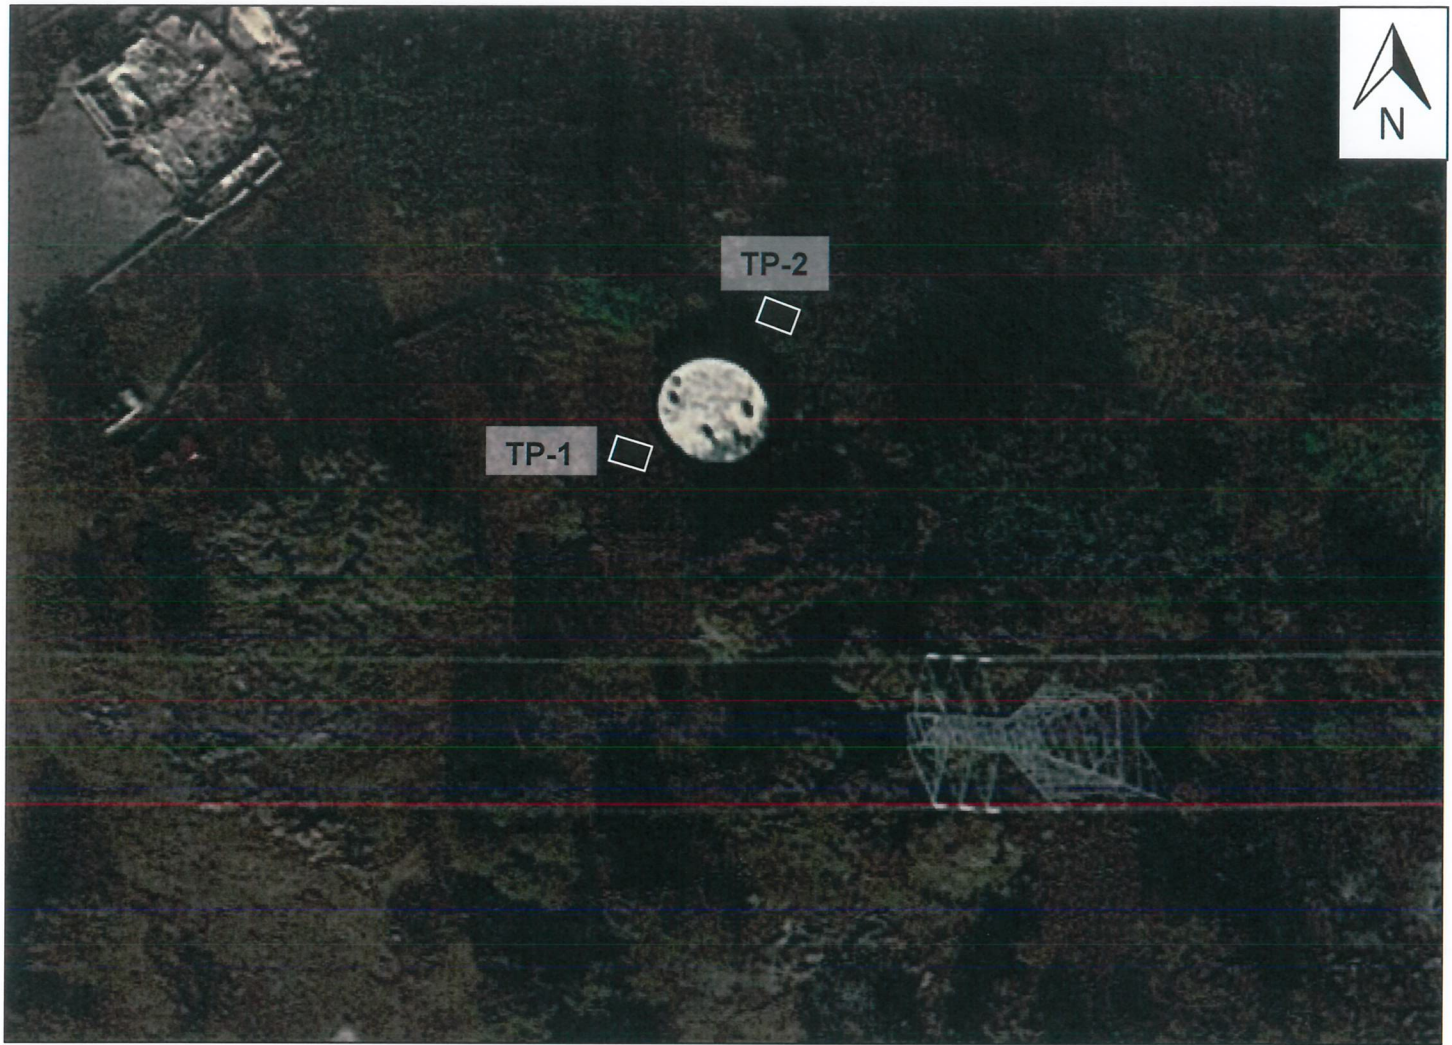
TEST PIT LOCATION MAP  
PROPOSED REPLACEMENT WATER STORAGE TANK  
212 MEADOWCROFT WAY  
SANTA ROSA, CALIFORNIA

building site. The test pits were excavated to depths of between three and one-half to five feet below the existing ground surface. The approximate test pit locations are shown on the Test Pit Location Plan, Plate 2. Test pits were excavated to observe the soil, bedrock, and groundwater conditions, and to collect samples of the underlying soils and bedrock for visual examination and laboratory testing. Detailed descriptions of the subsurface conditions are shown on the Test Pit Logs, Plates 3 and 4. The excavation and sampling procedures, laboratory procedures and descriptive test pit logs are included in Appendices A and B, respectively.

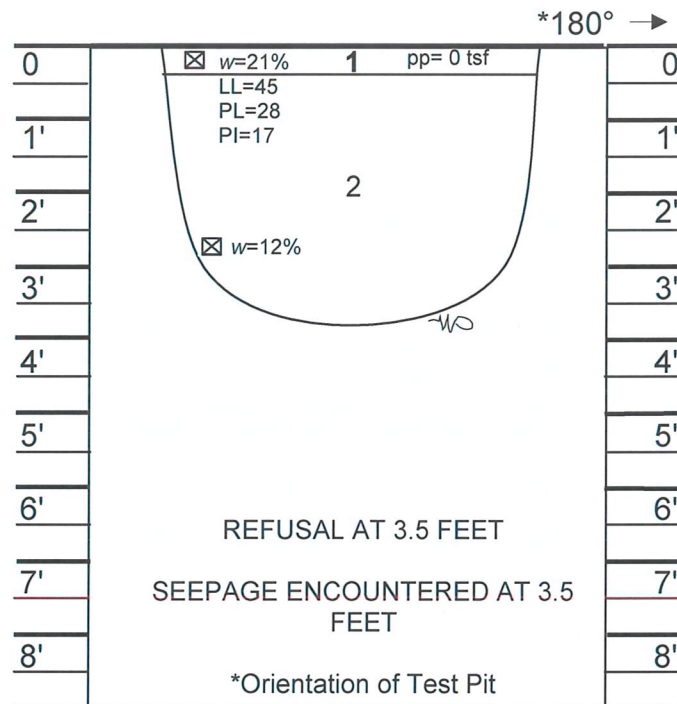
LOG OF TEST PIT 1  
PROPOSED REPLACEMENT WATER STORAGE TANK  
212 MEADOWCROFT WAY  
SANTA ROSA, CALIFORNIA

- 1) 0.0-0.25'; SANDY SILT (ML); reddish brown and black, moist, very soft, medium plasticity, porous, with roots (TOPSOIL).
- 2) 0.25'-3.5'; BASALT (Tsv); gray, hard, strong, moderately weathered, moderately fractured (BEDROCK).

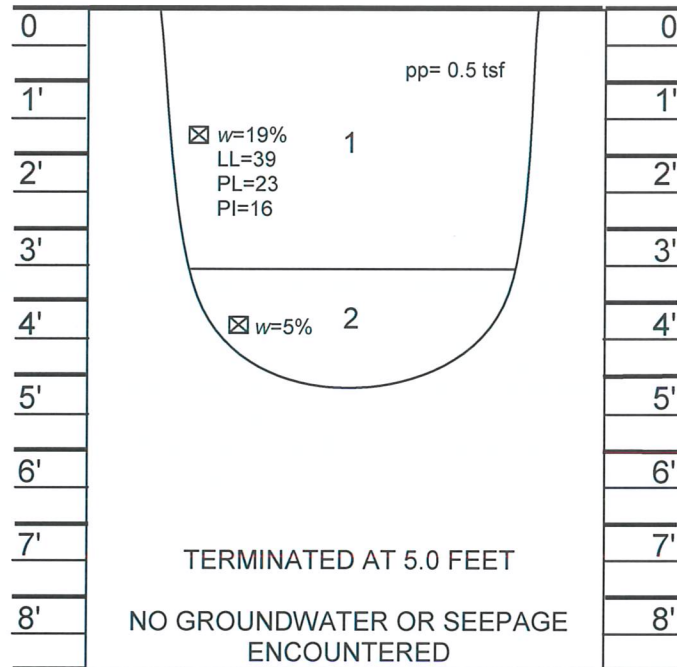
LOG OF TEST PIT 2  
PROPOSED REPLACEMENT WATER STORAGE TANK  
212 MEADOWCROFT WAY  
SANTA ROSA, CALIFORNIA

- 1) 0.0'-3.5'; SANDY CLAY (CL); reddish brown, moist, loosely compacted, medium plasticity, porous, trace roots, with sub-rounded and sub-angular basalt gravels (FILL).
- 2) 3.5'-5.0'; BASALT (Tsv); gray, hard, strong, moderately weathered, highly fractured (BEDROCK).
